# Flooring Issues Knowledge Base

This site will cover specific issues taken from actual complaints and will highlight problems, their causes and how to resolve them.

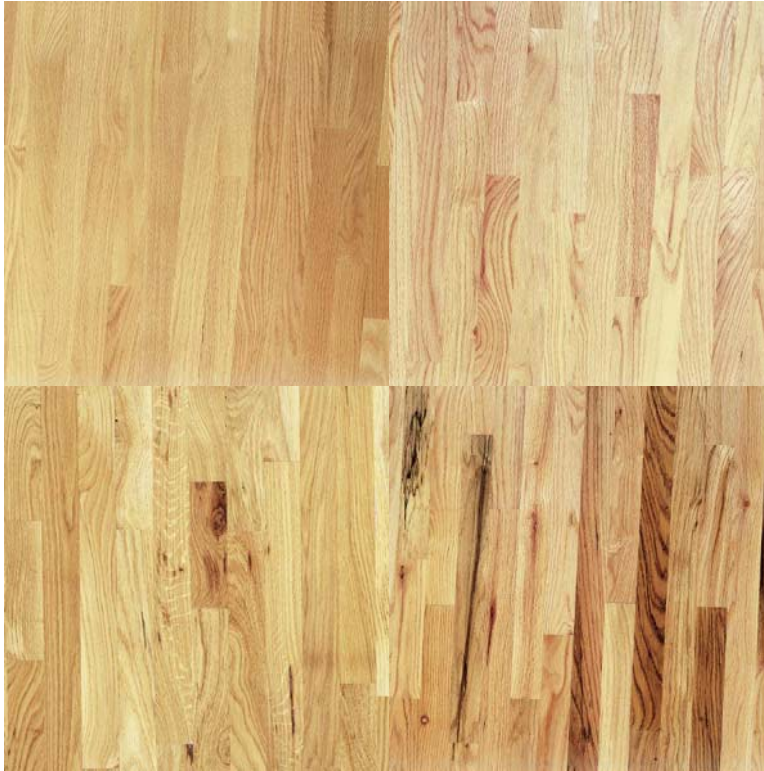
- Next, grade; wood flooring is graded as to color, grain, knots, bird pecks, pin worm holes, burls, bright sapwood, checks, brown streaks, mineral streaks, silica and biological content, machine burns, sticker stain, splits, cracks, how the wood is sawn, and the length of the boards. Obviously the less of these in a piece of flooring the higher the grade, for example: Clear grade plane sawn wood flooring is made from predominantly heartwood with a minimum number of character marks, and discoloration, providing a uniform appearance while allowing for all natural color variations seen in heartwood. Each subsequent grade is allowed to have more of each character as you move from Clear Grade to Select Grade to number one Common Grade to number two Common Grade. **NOTE: Exotic wood species by the nature of where they are grown may contain silica, crystal formations, or biological elements even in CLEAR grade. These may appear as small white specks or lines in the grain of the wood. If prominent, the installer can cull out (not install) boards that contain these characters or use them in unseen areas such as the back of closets or under cabinets.** Here are examples of the four most common grades of wood flooring starting with clear at the top left, select top right, #1 common bottom left and #2 common bottom right:
